This particular repair was in Round Rock, TX. 42 Neo with catastrophic damage to the drain area.

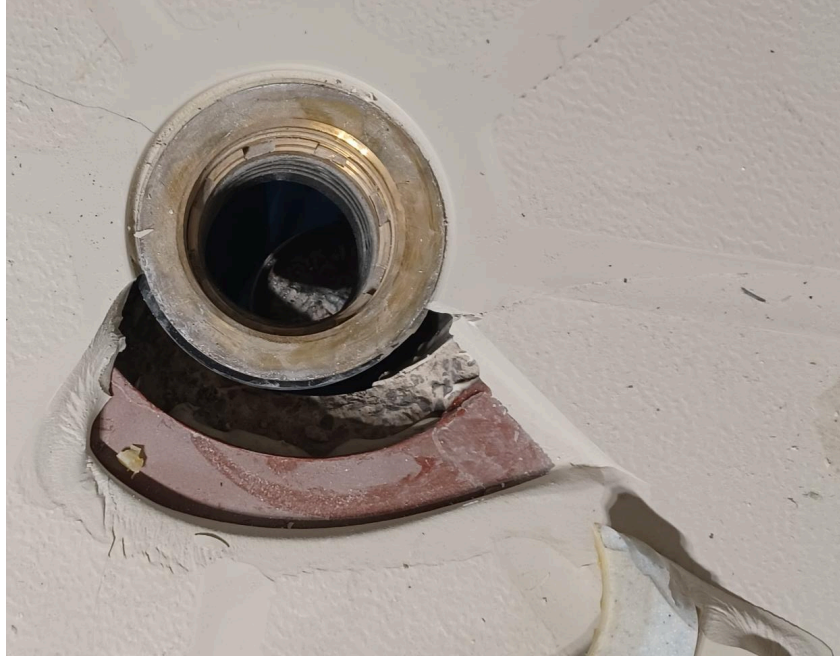
The event causing the damage is unknown, but it was strong enough to bend the brass drain. You don't see that every day.

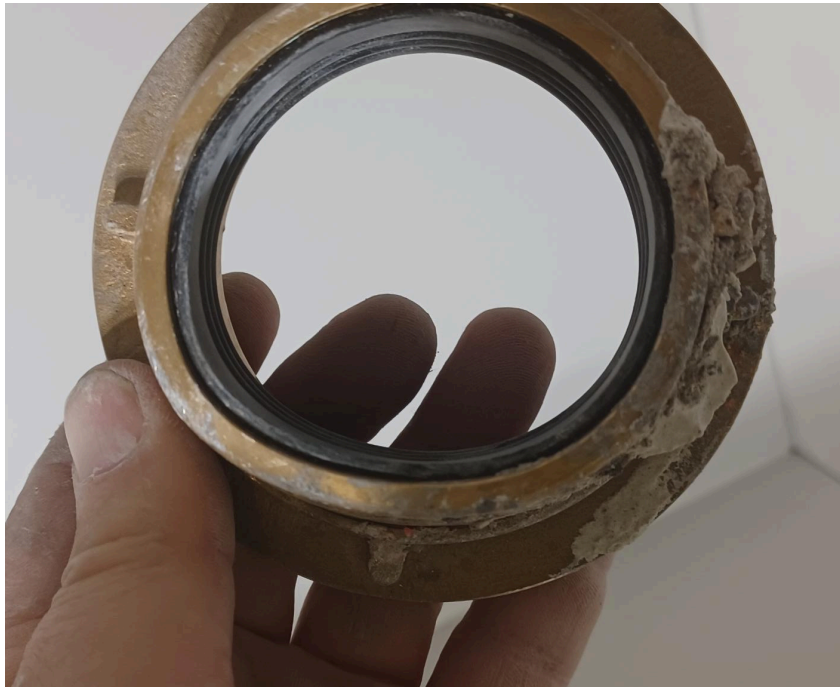
The damaged drain area extended outward in multiple directions.

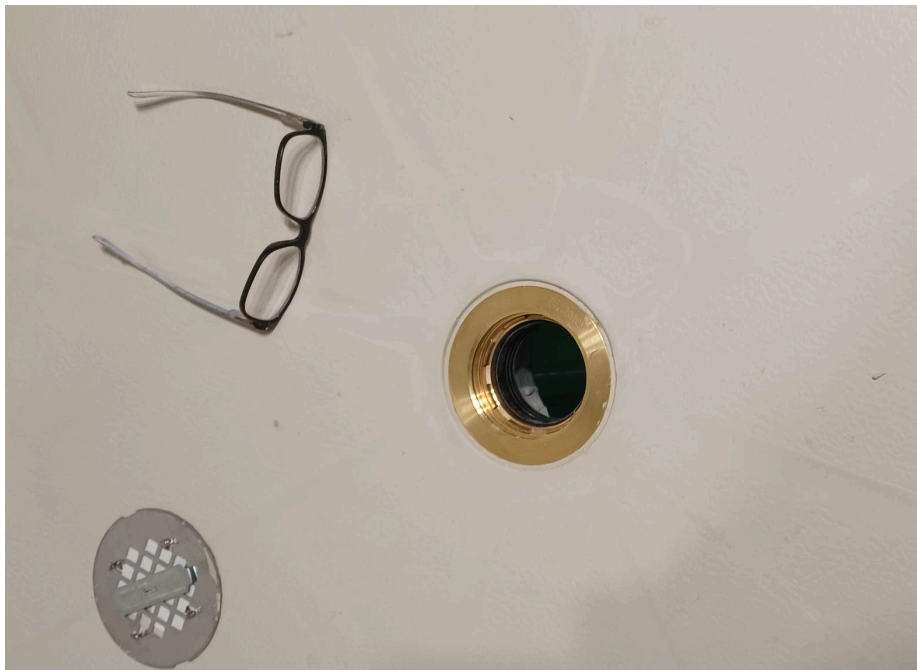
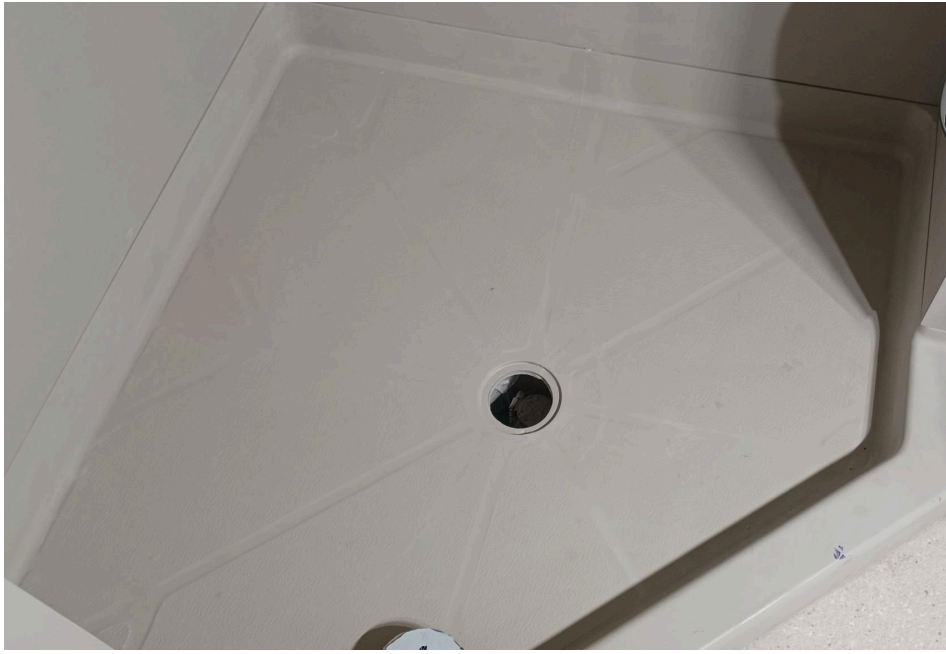
After proper curing, the areas are sanded, as shown below.

David Rusher, our in-house chemist and repairman, utilized Vendura's easy-to-use repair kit to fill the damaged areas. Our repair kits provide a fully welded area, no seams, no knit lines, and no weak bonds. These kits are not 3rd party products. They consist of the proper resin, filler, and colorants that are consistent with the original material.
